# Manhole Inspection Summary

Manhole # S25YY\_009MH

Insp Date: **6/18/07 10:33 PM**

**Location** Address: **1343 CLIPPER HEIGHTS AVE**

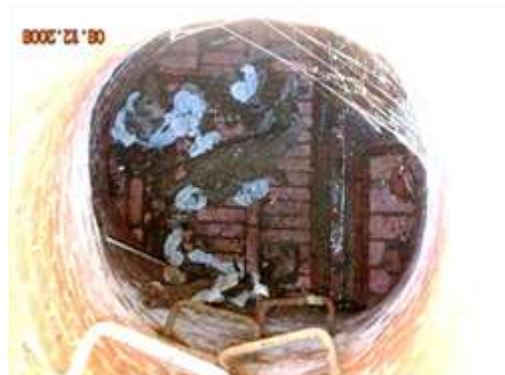
Top View

Corroded steps. Bench debris.

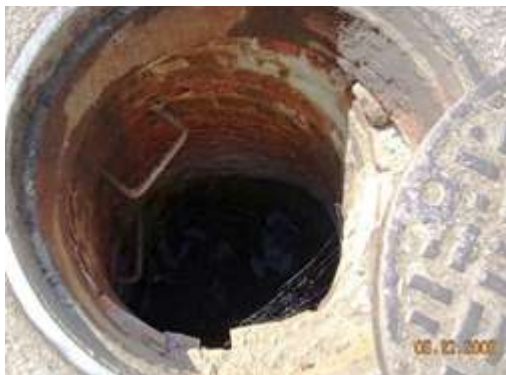
Defect

Frame leaks. Frame offset. Adjustment deterioration and infiltration. Corbel and Barrel infiltration - other side.

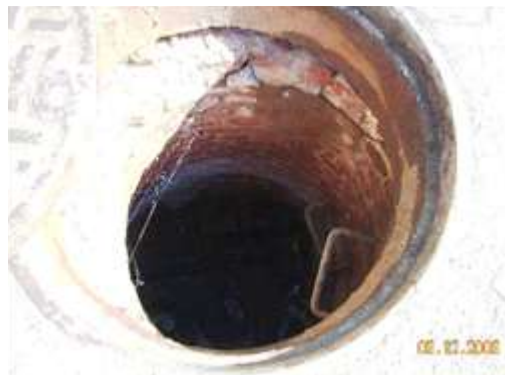
Defect

Frame leaks. Frame offset. Adjustment deterioration and infiltration. Corbel and Barrel infiltration.

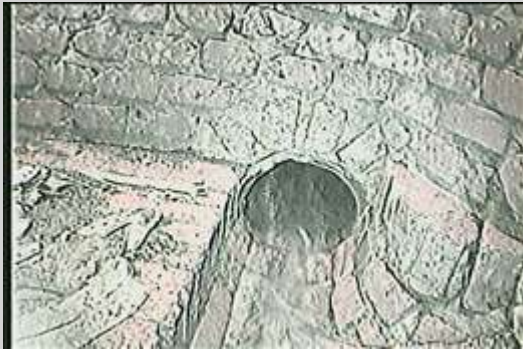
### 8 in. Circular Gravity Sewer Pipe Out @ 12 O'Clock

Infiltration: **Evidence** Pipe Seal Cond: **Unknown**

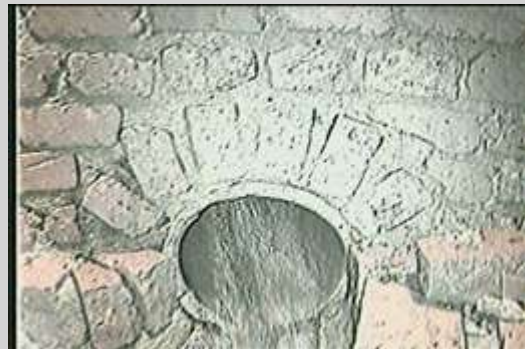
### Drop In @ 3 O'Clock

Barrel deterioration and infiltration. Channel deterioration.
